AERIAL PHOTOGRAPHIC ANALYSIS OF THE LARSON AFB STUDY AREA Moses Lake, Washington

EPA Region 10

TS-PIC-89818/90818-1
November 1989

M. A. Finkbeiner
Environmental Programs
Lockheed Engineering and Sciences Company
Las Vegas, Nevada 89193-3478

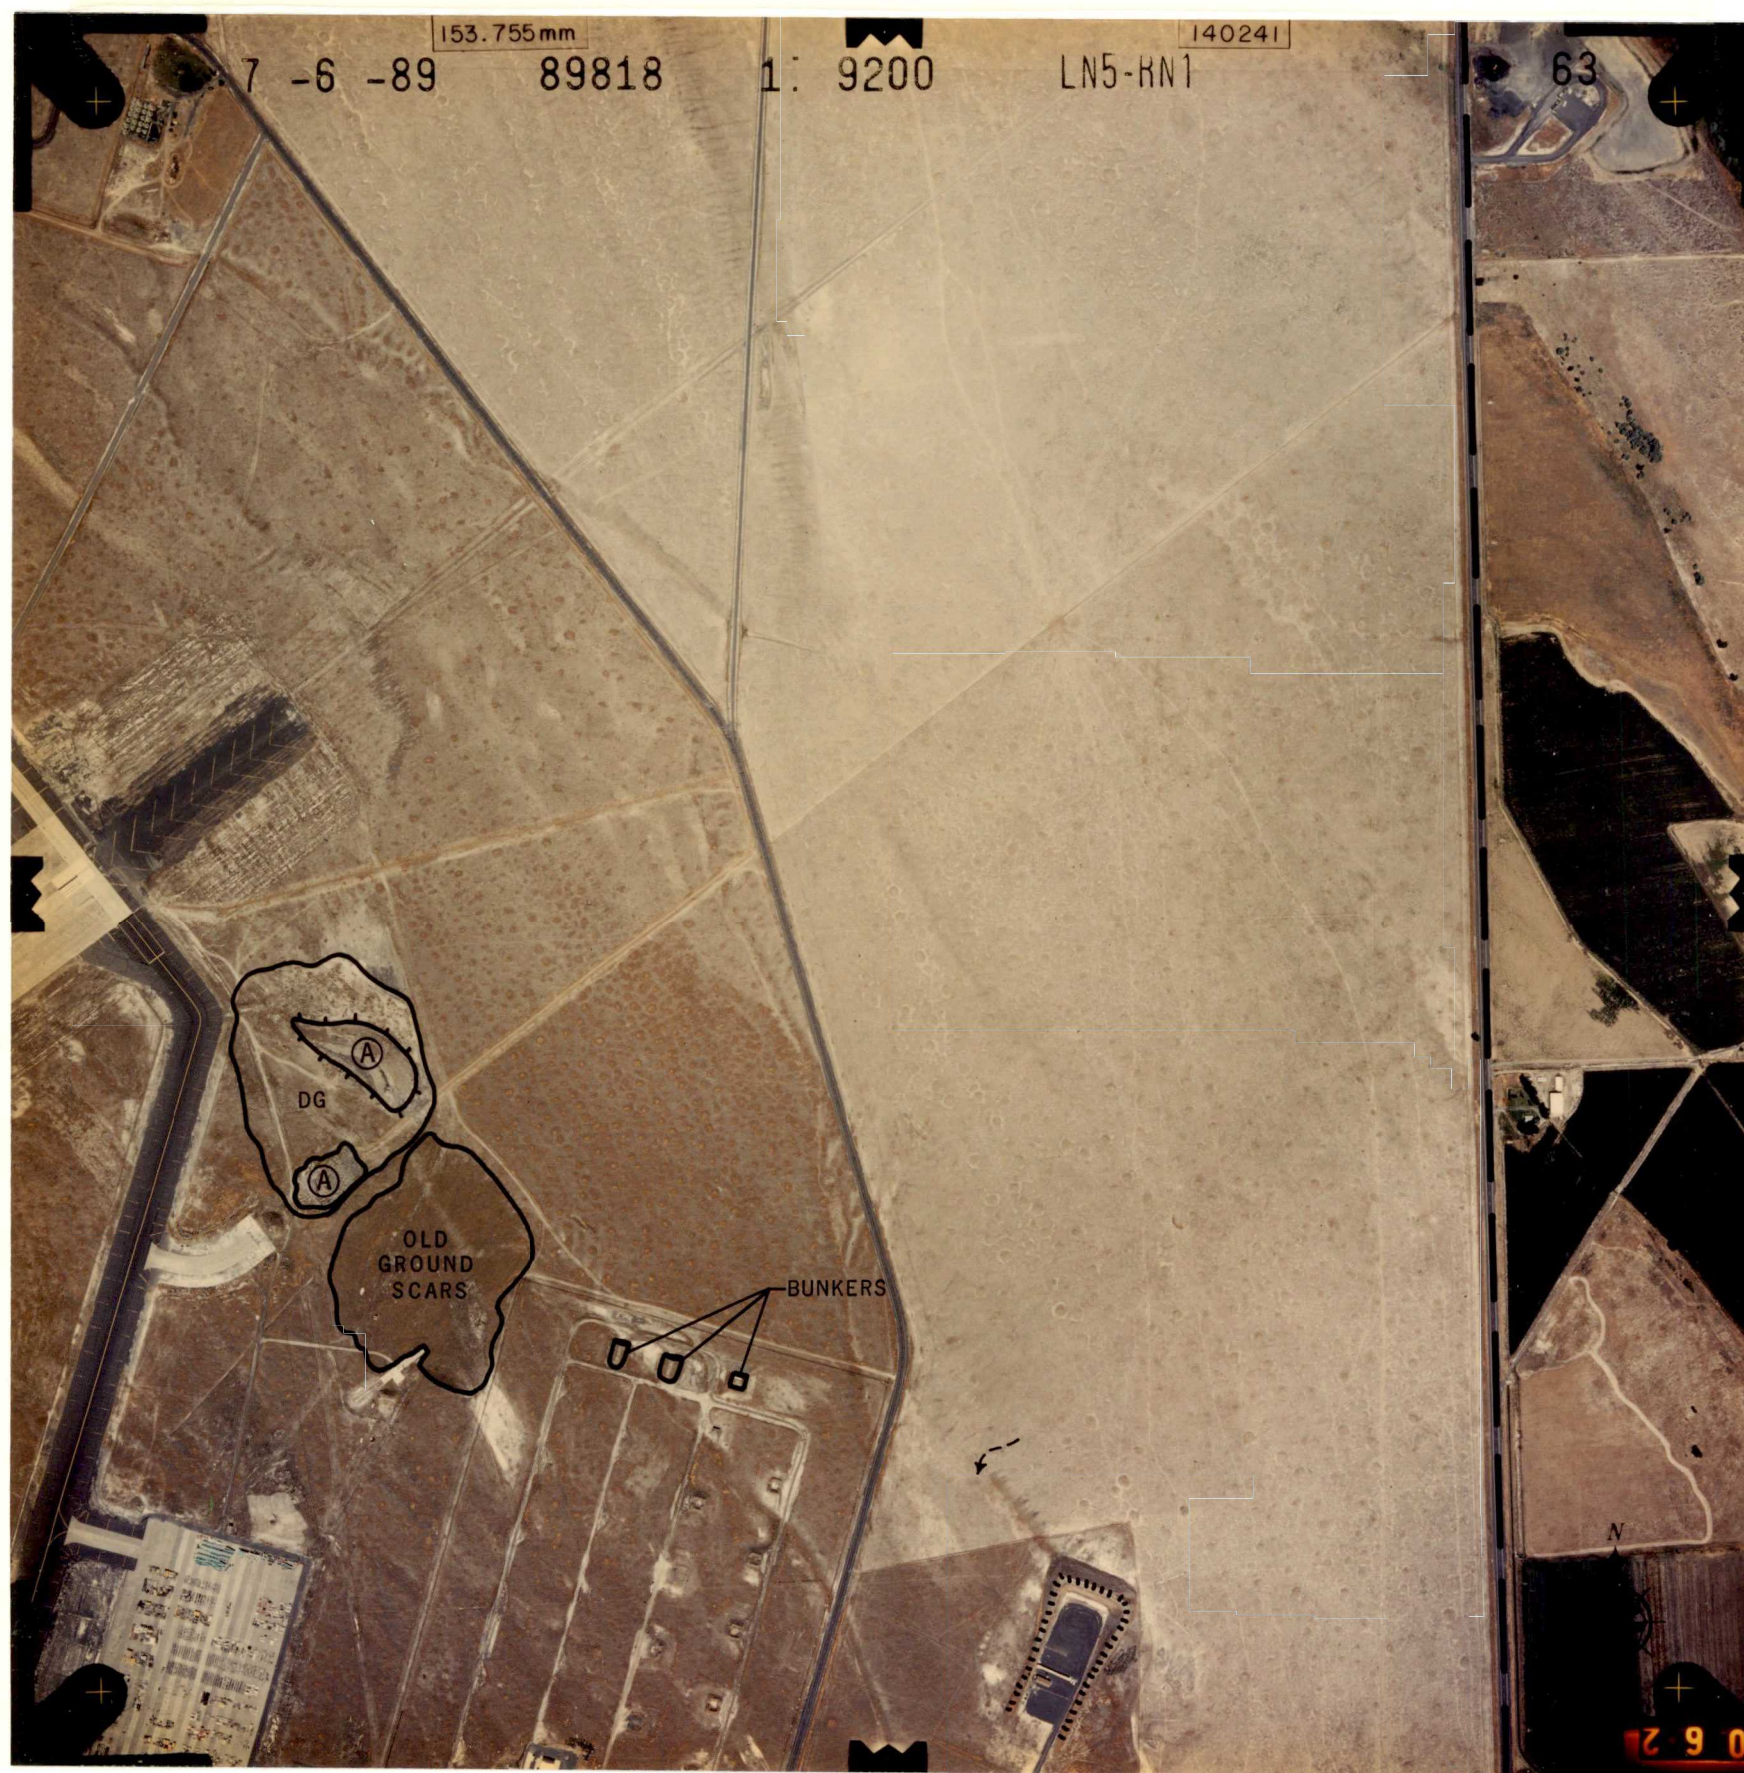
JULY 6, 1989 (17 of 20)

No change is evident since 1973. The old ground scarring area shows signs of revegetation.

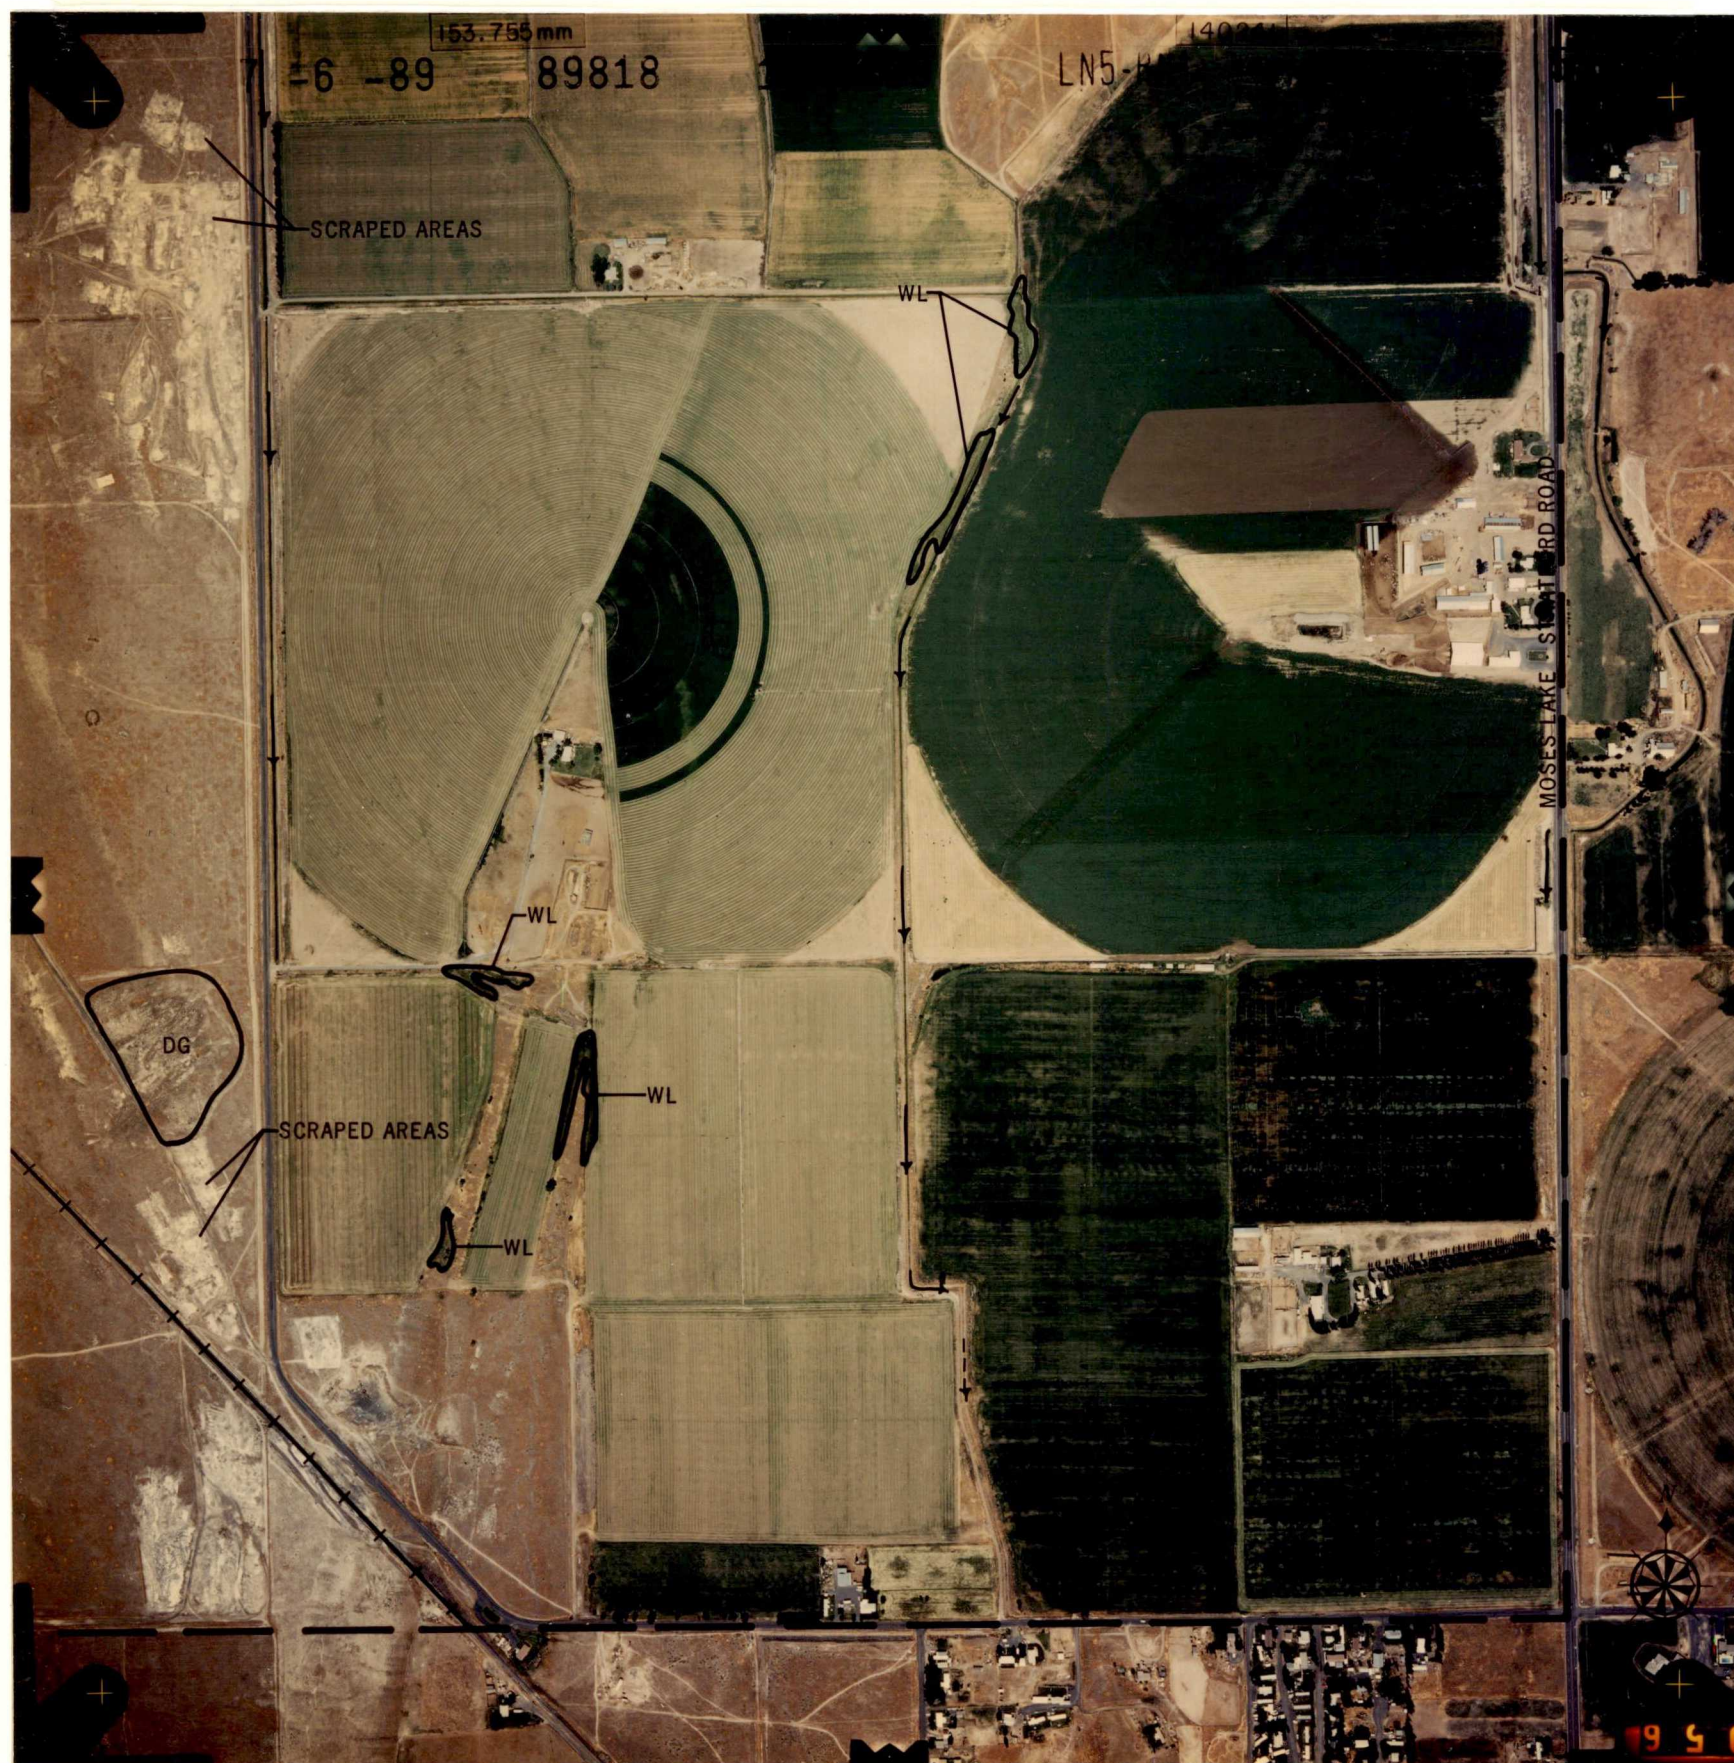
Figure 30. Larson AFB study area, July 6, 1989 (20 of 20). Approximate scale 1:9,200.

Figure 30 shows revegetation of the disturbed ground on the west side of the frame. Five small wetland areas are also present where irrigation runoff has accumulated. No potential environmental hazards are noted.
